**City of Akhiok, Kodiak Island, Alaska
Power System Assessment**

**Findings and Recommendations Report
14 October, 2015**

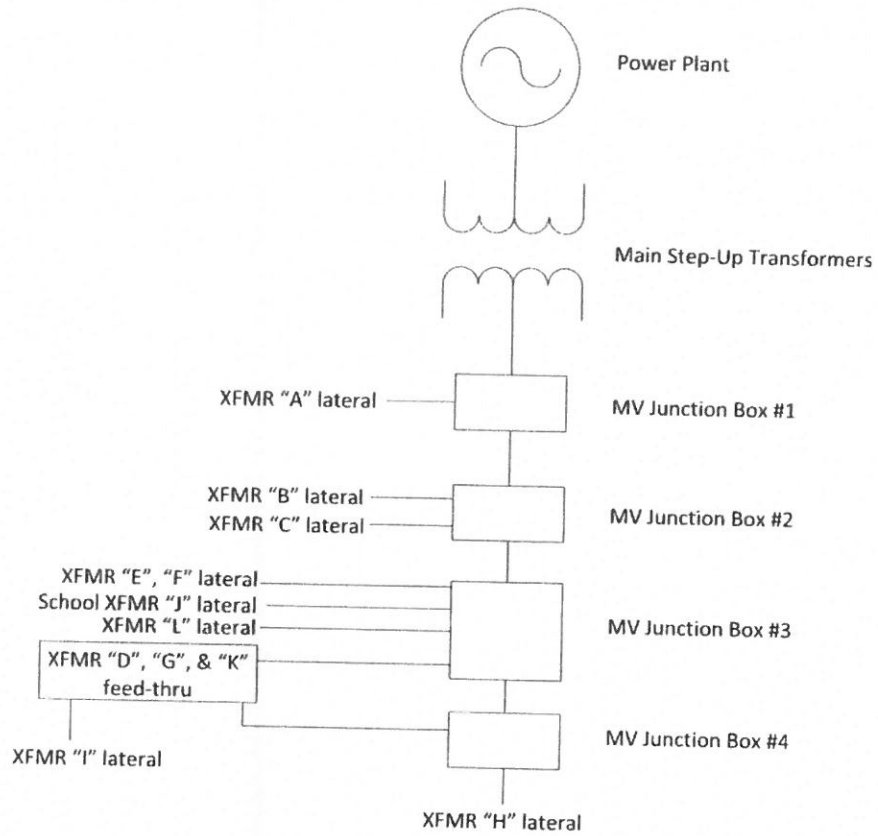
Figure 8 - Power System Simplified Diagram

A series of MV junction boxes are used to redirect the three phase power via load break junctions (LBJ's) to transformers and other MV junction boxes. The MV junction boxes are typically of fiberglass construction. The LBJ's are 3-point or 4-point (meaning that there can be up to three or four load break elbow connection points per phase). Unused LBJ bushings typically have insulated caps. A simplified diagram of the Akhiok distribution system is shown in Figure 8.

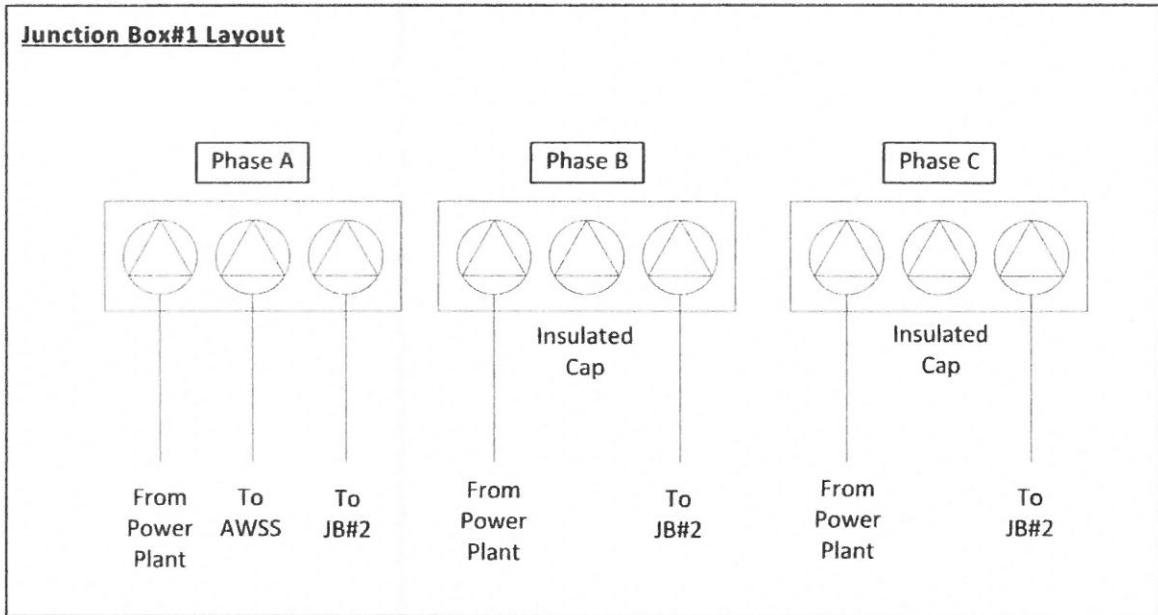
Figure 9 - Junction Box #1 Layout

There are a total of four MV junction boxes in the distribution system. The first (JB#1) is near the airstrip, approximately 550 feet from the power plant. A tap on the Phase A LBJ in JB#1 feeds the Akhiok Weather Station. Figure 9 shows the layout of JB#1.

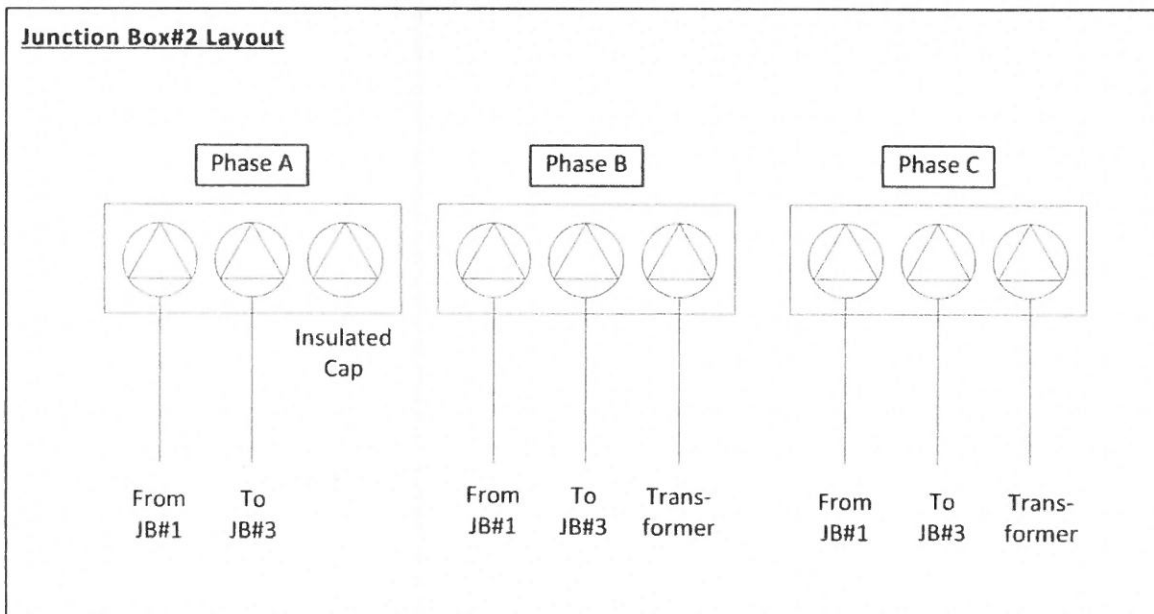
Figure 10 - Junction Box #2 Layout

The second junction box is located on Airport Way near the first group of homes (refer to the appendices for distribution system maps), approximately 1000 feet from JB#1. Figure 10 shows the layout of JB#2. It is likely the Phase B & C cables feed the two distribution transformers that are in the immediate vicinity of the junction box. However, transformers are not clearly identified, so it is unclear which loads are supplied by these cables. The maps included in the appendices show a best guess at the routing of feeder cables between MV junction boxes and to distribution transformers.

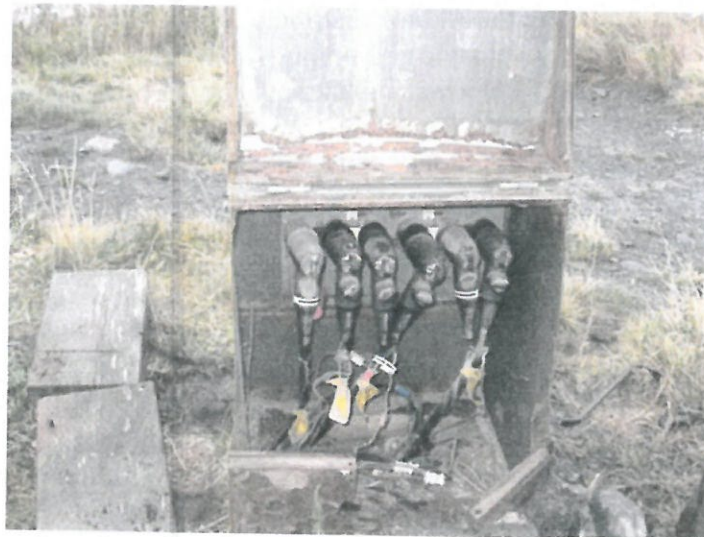
The fourth junction box is approximately 500 feet from JB#3 and near the City Office building. JB#4 is a steel enclosure (as opposed to the fiberglass construction used with the other junction boxes) and has rusted to the point that it is open to the environment (See Figure 12). A temporary plywood enclosure was built to protect this equipment.

Figure 12 – Rusted Junction Box #4

1. Safety concerns, including padlocks on transformers and MV junction boxes, replacement or reinforcement of JB#3 enclosure, and replacement of JB#4 enclosure
2. Balance phases A, B, and C loads in system, at MV or LV level (school?)
3. Distribution system cable and infrastructure replacement
4. Maintenance activities
5. Distribution transformer replacement
6. Check voltage levels under peak loading
7. Future planning/assessments

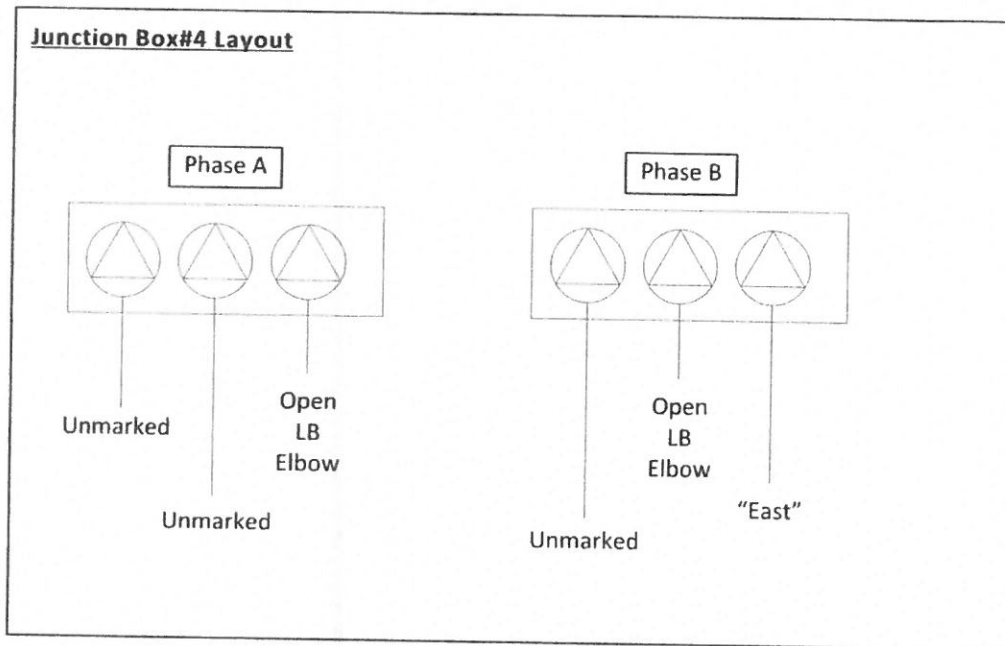
Figure 13 - Junction Box #4 Layout

Since only two feeder cables are brought to this enclosure (Phases A & B), only two LBJ's exist. Figure 13 shows the layout of JB#4. Phases A & B are assumed left to right, as this matches

other junction box layouts). The labels in this junction box could not be read, except for one marked "East". The incoming feeder cables are unmarked. One feeder cable on the Phase A LBJ is also unmarked. It is likely both load cables supply the transformer that is approximately 50 yards east of JB#4 (Transformer "H"). Inspection of the transformer revealed that two incoming MV cables exist, with one load break elbow connected to bushing H1B and the second elbow on a parking stand. The second feed provides some measure of redundancy for this transformer.

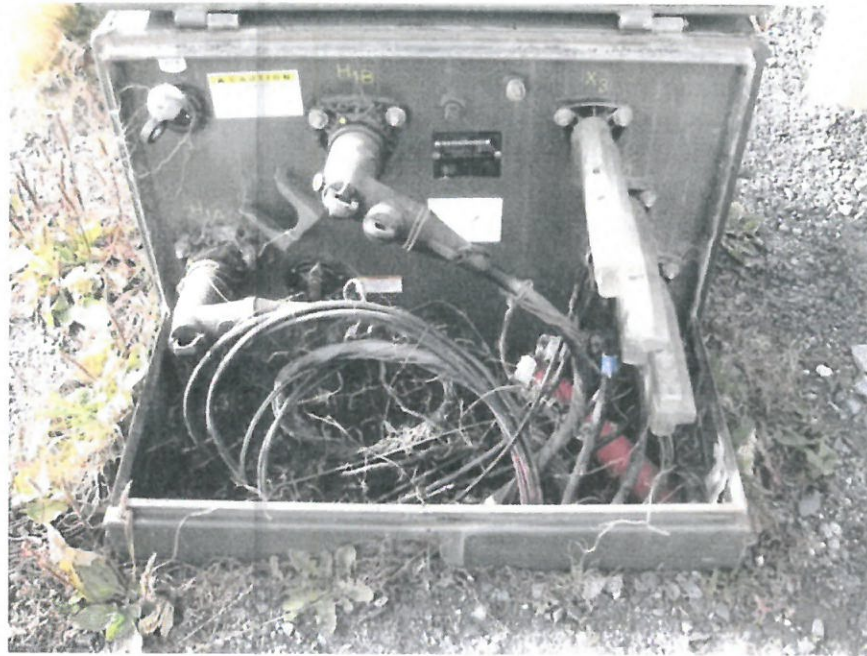
The health clinic transformer is rated 25 kVA and is a feed-thru (see Figure 14). The 240 V electrical load on the panel at this facility was minimal (3-5 amps) on 9/26, although there were no patients in the clinic at the time and medical equipment was not operational. Voltage at a convenience receptacle inside the clinic was found to be 119.5 V under low load conditions.

Figure 14 – Health Clinic Transformer

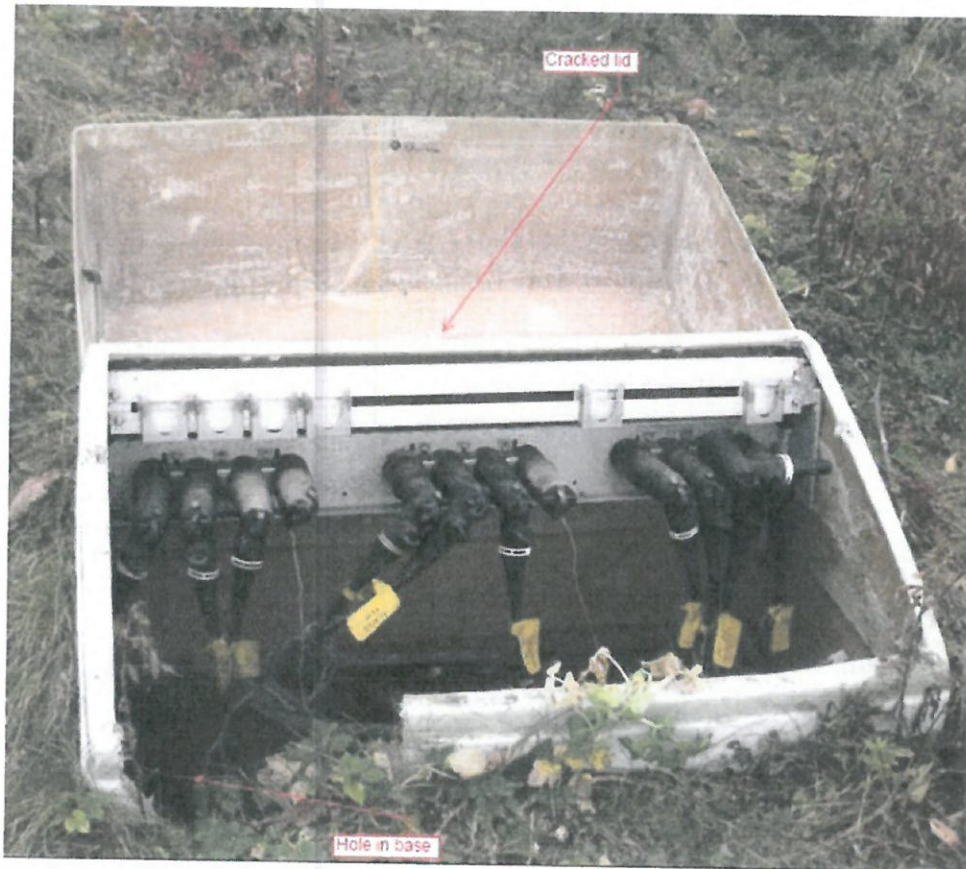
Electrical safety is a concern. The MV junction boxes are subject to damage due to their construction material. One of the fiberglass lids (JB#2) was blown off by high winds, leaving the MV cables and terminations exposed both to the environment and to Akhiok residents. Another was damaged during a traffic incident, leaving a large hole on the side and structural damage to the lid (See Figure 15). Children were observed playing on and around this damaged enclosure.

Figure 15 – JB#3 Damage

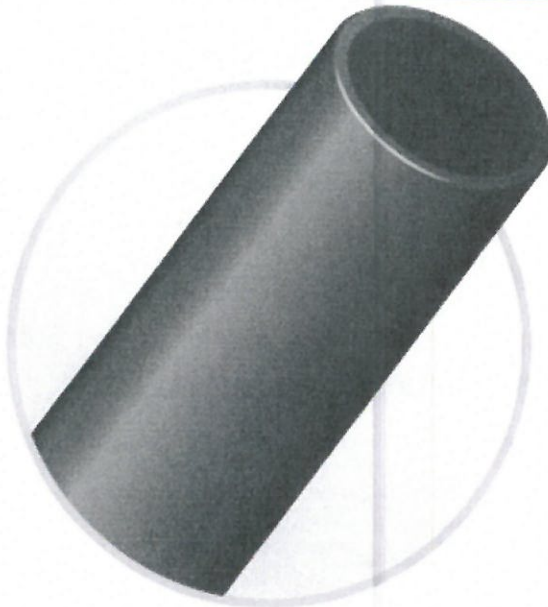
FEATURES:

- ETL Listed to UL 651A, used per NEC Article 353
- Manufactured from flexible HDPE, makes gradual bends without special equipment
- Excellent low temperature properties, for better handling in cold climates
- Outstanding ductility and strength, protects cables from shifting ground
- Protects cables from rock and root impingement, increasing UG cable life
- Provides a permanent pathway, simplifies future cable repair and replacement
- Added UV stabilization package
